RADC-TR-74-329 Final Report January 1975

MILLIMETER WAVE COMMUNICATIONS PROGRAM: LINK TESTS OF HIGH SPEED DIGITAL RADIO SET AN/GRC-173(XW-1)

Raytheon Company

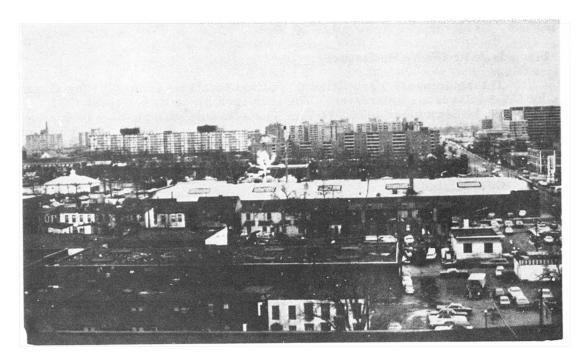
Figure 13. View from Rooftop at WNY Site - Looking Towards Pentagon

The ground terrain over the path is characteristically flat and nearly at sea level. However, buildings several stories high along the path line raise the effective height of the terrain and this dictated the use of roof-top installations to achieve clearance. Towers (e.g., periscope antenna systems) to further increase clearance were, however, found to be unnecessary. Figure 13 is a view from the Washington Navy Yard looking generally towards the direction of the Pentagon and taken from a height approximately 20 feet lower than the final antenna boresight.

It is estimated that the first Fresnel zone clearance is approximately 13 feet. The antenna beam is narrow (0.35° half-power beamwidth) and traverses a line high enough above the Potomac River so the communications channel is relatively free of surface layer and duct effects associated with non-standard atmospheric conditions above the surface of the water.

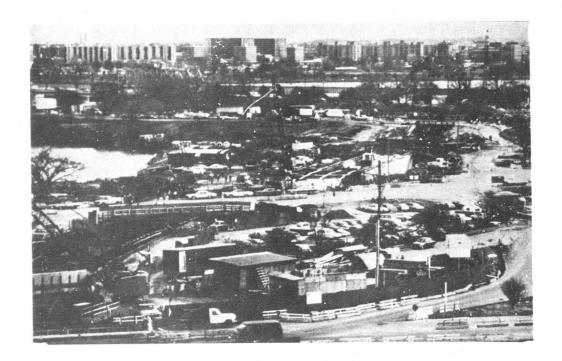
Figure 53. View of Construction in Link Path Near Pentagon

Figures 53 and 54 illustrate the type of construction which occurred. The tall cranes were believed to have caused the worst problem. It is also possible that reflections from the other metallic surfaces had an effect at times. These photographs were taken standing near the edge of the Pentagon building and within a few degrees of boresight.

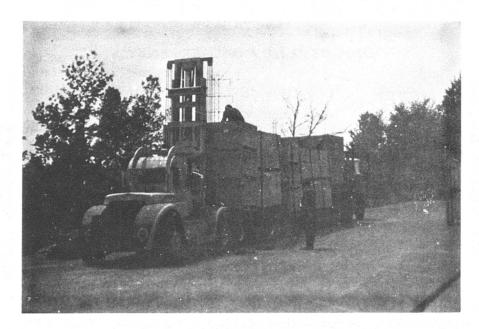
Figure 74. Loading Equipment For Shipment By Flatbed Trailer Truck

Figure 74 is a photograph of the loading operation onto one of the flatbed vehicles at the Raytheon plant.

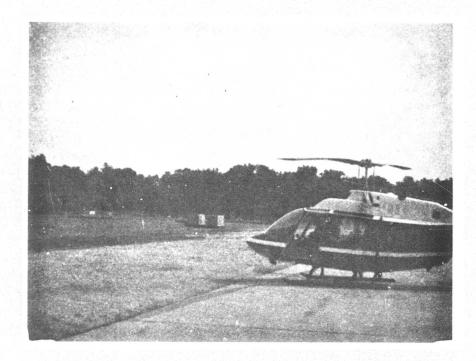
Figure 75. Equipment at Davison Airfield for Briefing During Storage Period

Storage was in an outside exposed area provided by the Government at Fort Belvoir, Virginia, for about two months prior to the actual installation. Note: the antenna systems had been stored at the Raytheon plant for about a year during Phase II and the shelter groups for about a month prior to shipment. Arrangements were also made while the equipment was at Fort Belvoir to hold briefings with helicopter base personnel from Fort Eustis, Virginia, and Davison U.S. Army Airfield at Fort Belvoir. Part of the briefing meeting included preliminary fly-over of the shelters, which were moved temporarily from their storage area to nearby Davison Airfield for this purpose. Figure 75 shows some of the radio set equipment near the flight apron at Davison Airfield during a meeting with the helicopter personnel. The helicopter shown in this picture, a Bell UH-1, was one of those considered for the lift mission, but not used, primarily since safety considerations required the use of a fail-safe multiengine craft for a lift over areas of the type of the Pentagon and WNY. The lighter craft shown, however, did prove of considerable utility for site inspection flights during final preparations.

A recommendation resulting from the storage experience is to put deeper openings in the shelter skid to accommodate standard fork lift truck forks. Special forks were obtained by Fort Belvoir personnel for the local lifting.

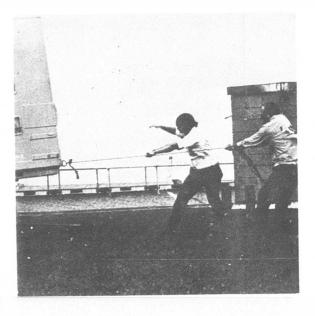
g. Guiding onto framework

Figure 76. Helicopter Lift at Pentagon

Figures 76 and 77 contain several photographs made of the lift missions. The photographs disclose details, such as methods of rigging and suspension, flight and personnel procedures, etc. The basic sequence of steps were as follows:
